An Illustrated Tale of Our Sanctuary Roof By David Newton, B&G

Much of the history of our remarkable Meeting House is interwoven with the history of the now infamous Sanctuary Roof. Come with me for an entertaining journey of discovery and improvements to our shared Meeting House home since about 1964.

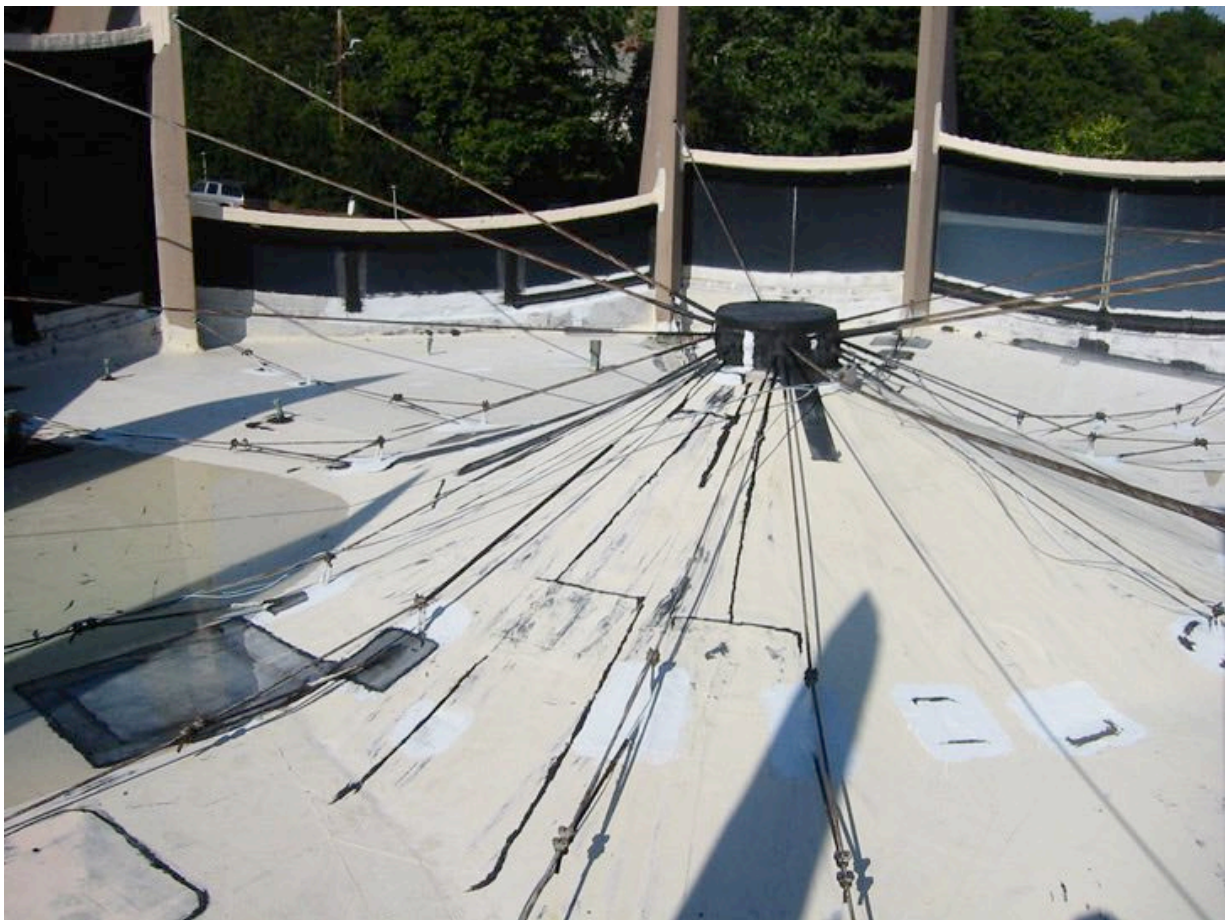
This is the roof. If you look carefully, you will see a lake on the left side! 2005

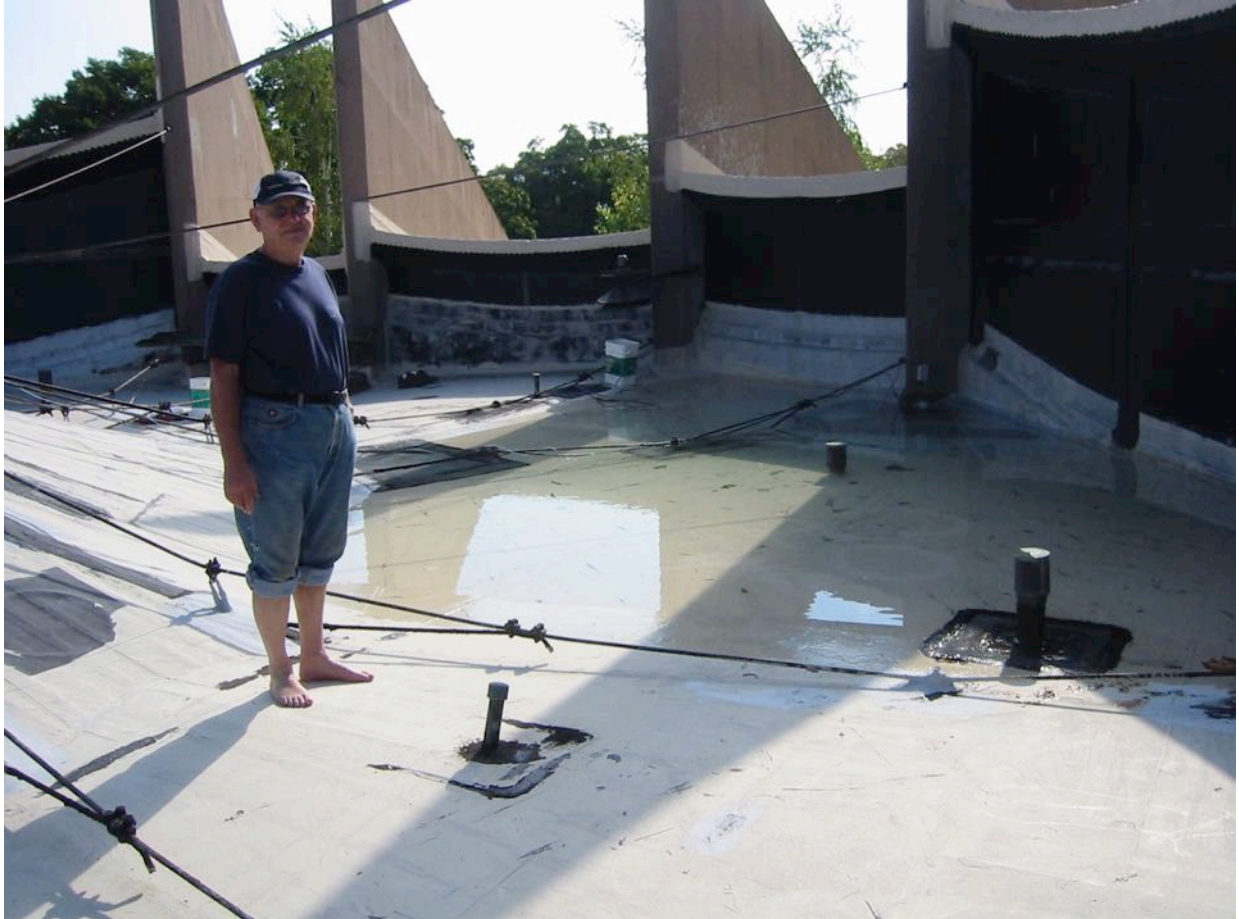
Stu Spence is preparing for wading in a pool to release a controlled flood through the unplugged drain. The pooled water, naturally leaked into the Sanctuary via any defects in the EPDM covering. 2005

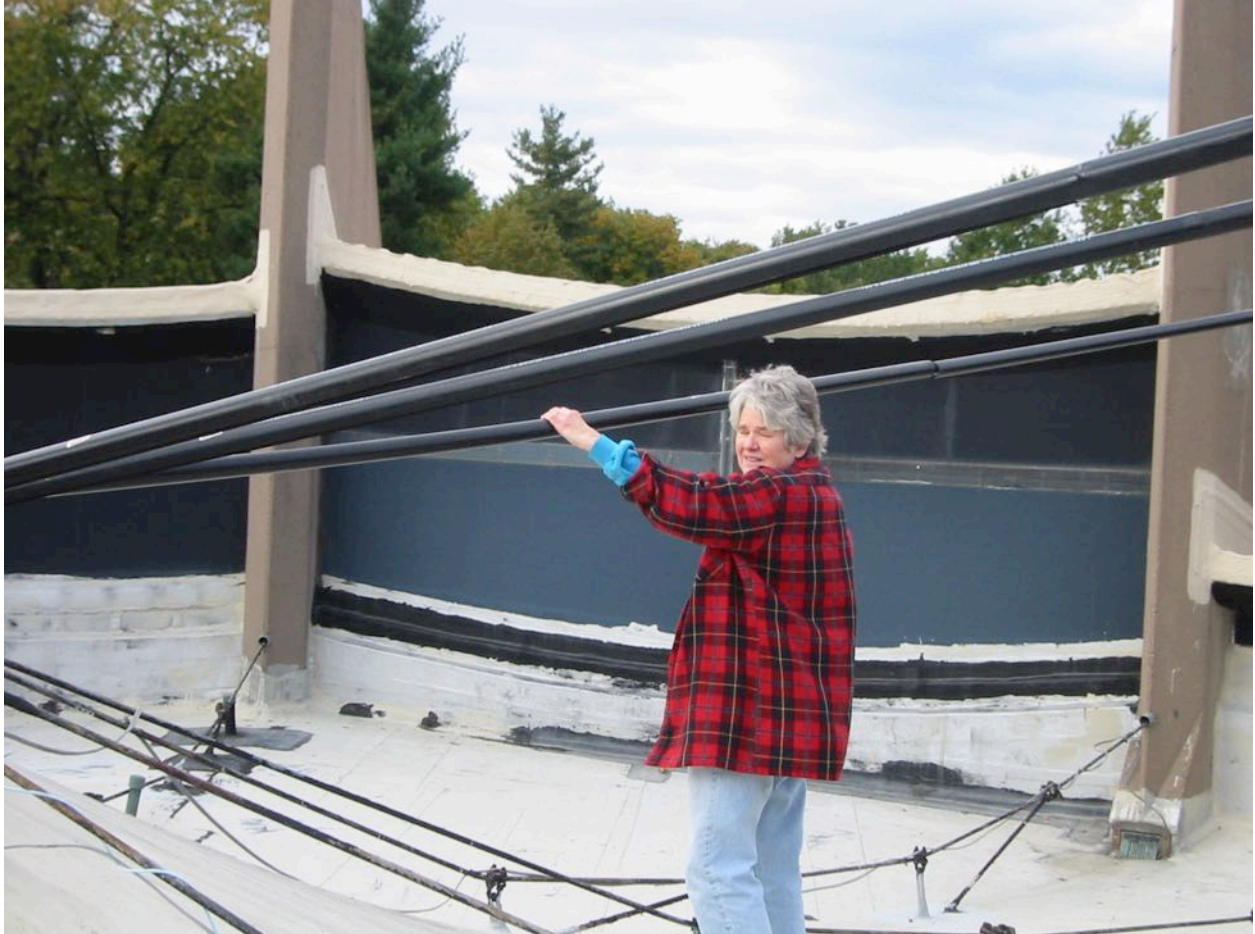
*Cables covered with plastic slotted plastic pipe to prevent water flowing down inside the wire cable to the hub and then into the sanctuary. Janice Newton assistening
10/29/2005*

Shortly thereafter, Janice and I went to Home Depot, purchased lengths of plastic pipe, and cut a slot into the pipes lengthwise, and set off to the Sanctuary roof to install our new invention to keep water out of the cables. It worked and to this day the cables remain covered. The slots at the bottom of the pipes are to make sure no water is trapped in the cables to cause rusting and deterioration.

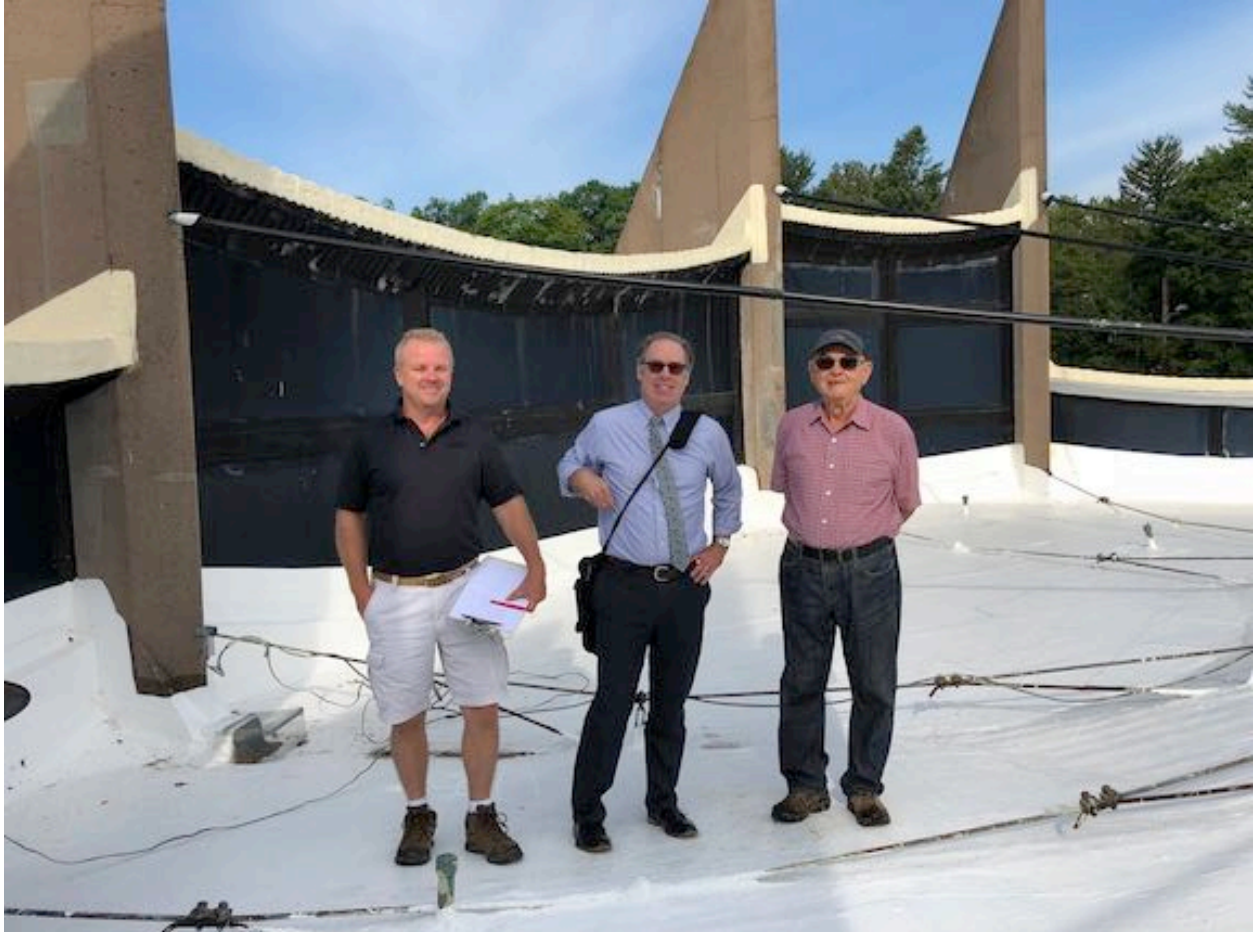
Completed Job - Left to Right, Eagle Rivet Roofing Contractor, Arthur Dias, Architect Hugh Schweitzer and Stu Spence, Chair of B and G

And, now the roof leaks little if at all.
