Volume of Berm Lake Increased for Flood Control 11/15/23

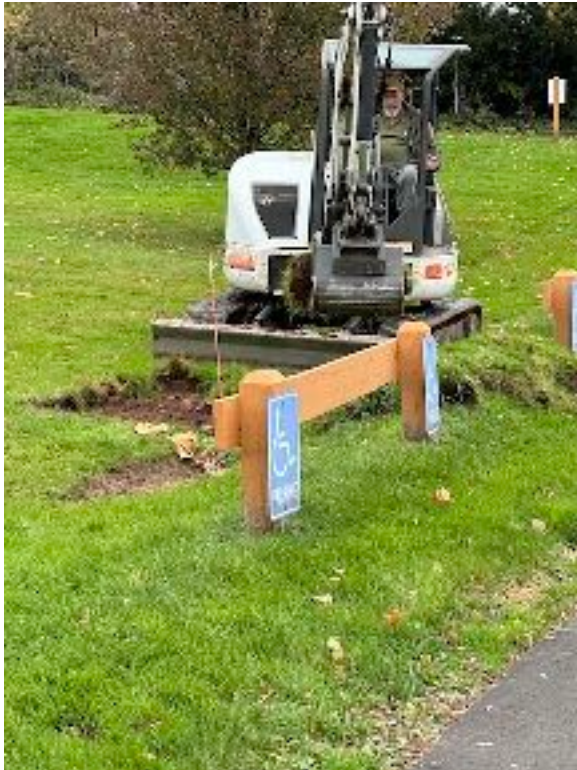
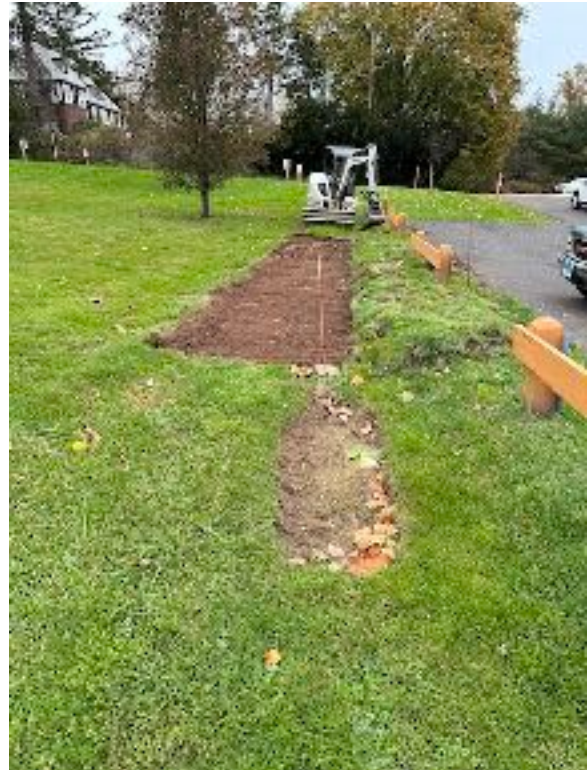
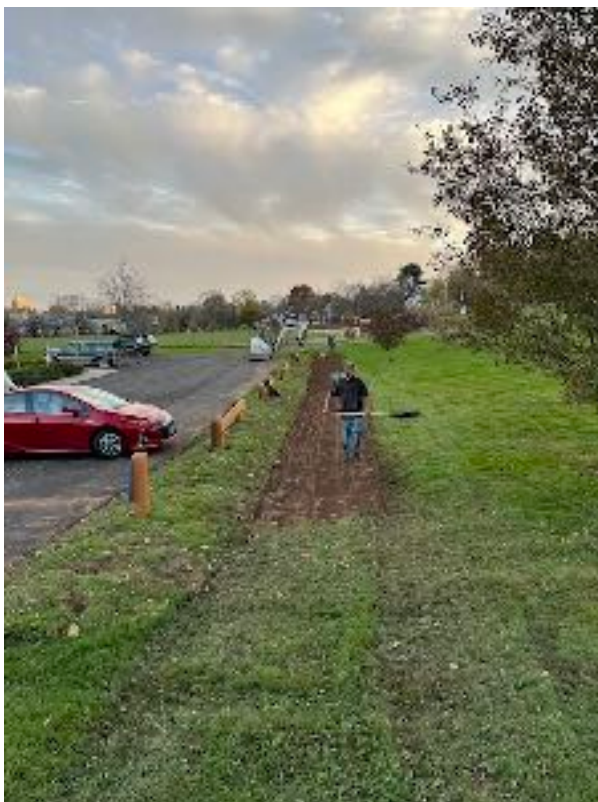
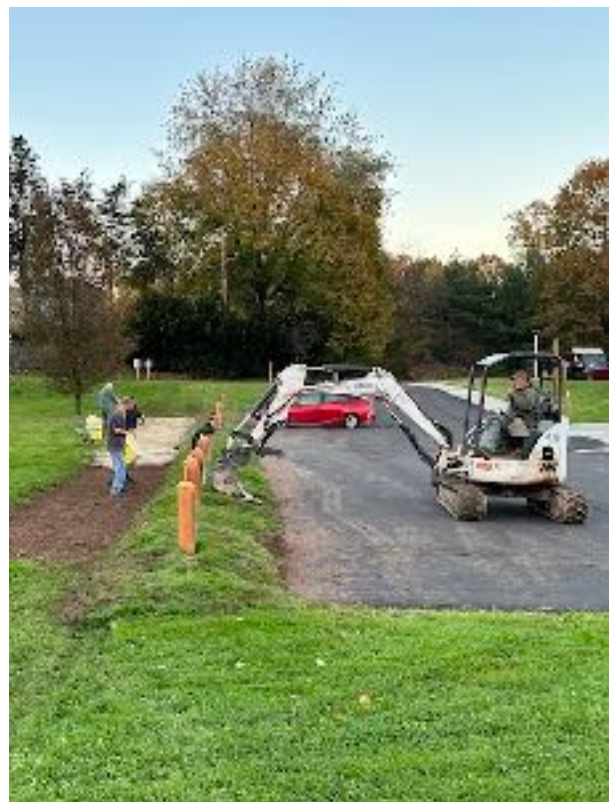
The series of photos above shows our recently completed efforts to increase the volume of water retained by the now higher berm. We believe this may well “buy” us another twenty minutes during heavy cloud bursts, and thereby save the wet vac emergency crew a large amount of work vacuuming up water and drying the carpets.

The channel through the lawn in front of the office has been deepened to better remove water in that vicinity to the catch basin under the Kousa Dogwood. The west drain has been restructured and is kept clean, and a berm was created initially to retain water flooding down toward the drain from the entire front lawn. It seems to have been working reasonably well.!

The berm lake water storage, therefore, prevents overwhelming the West drain as long as the retained lake is not overflowing. We point out here, there is a one inch pipe draining the lake, so the slow escape of the water in the ensuing day or two successfully returns the lawn to normal status.
