Meeting House Roof – A Continuing Saga

David Newton,
Secretary Pro Tem
Building and Grounds
August 2018

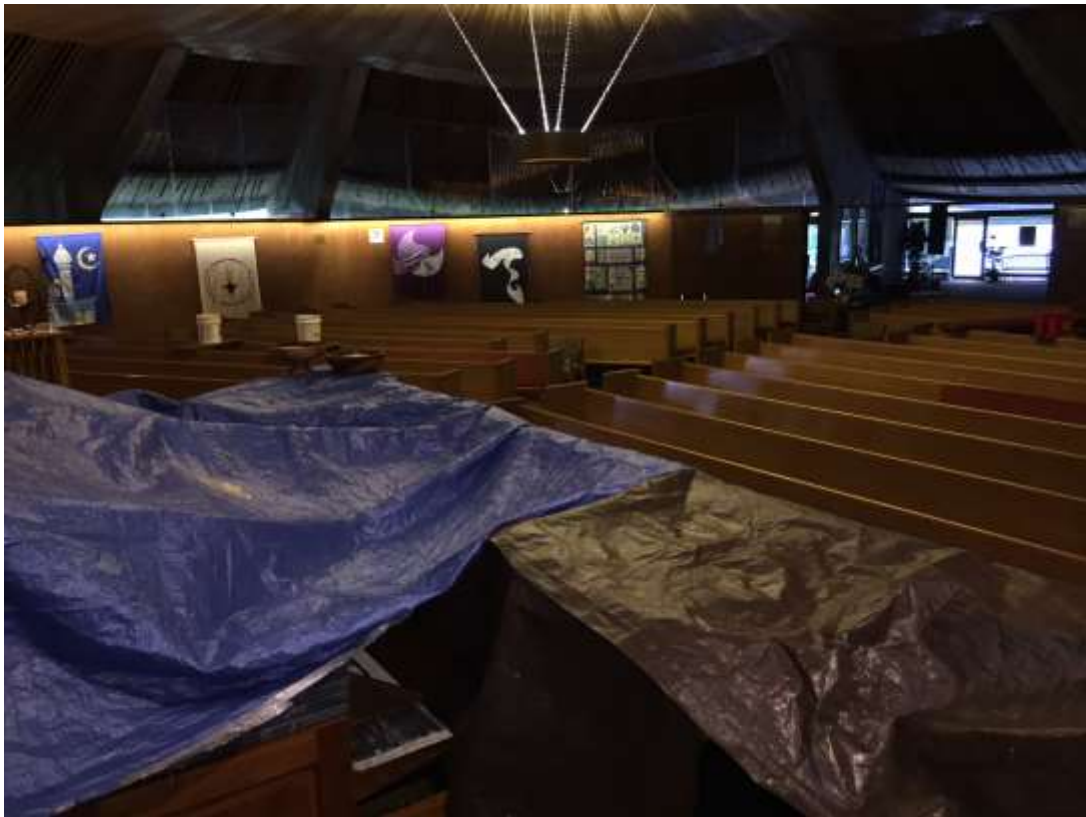
Periodically we have had rain, inside, and have even developed a common accessible storage of buckets, tarps and associated equipment. Our carpet and pew cushions were selected for indoor-outdoor capacity to withstand water without damage

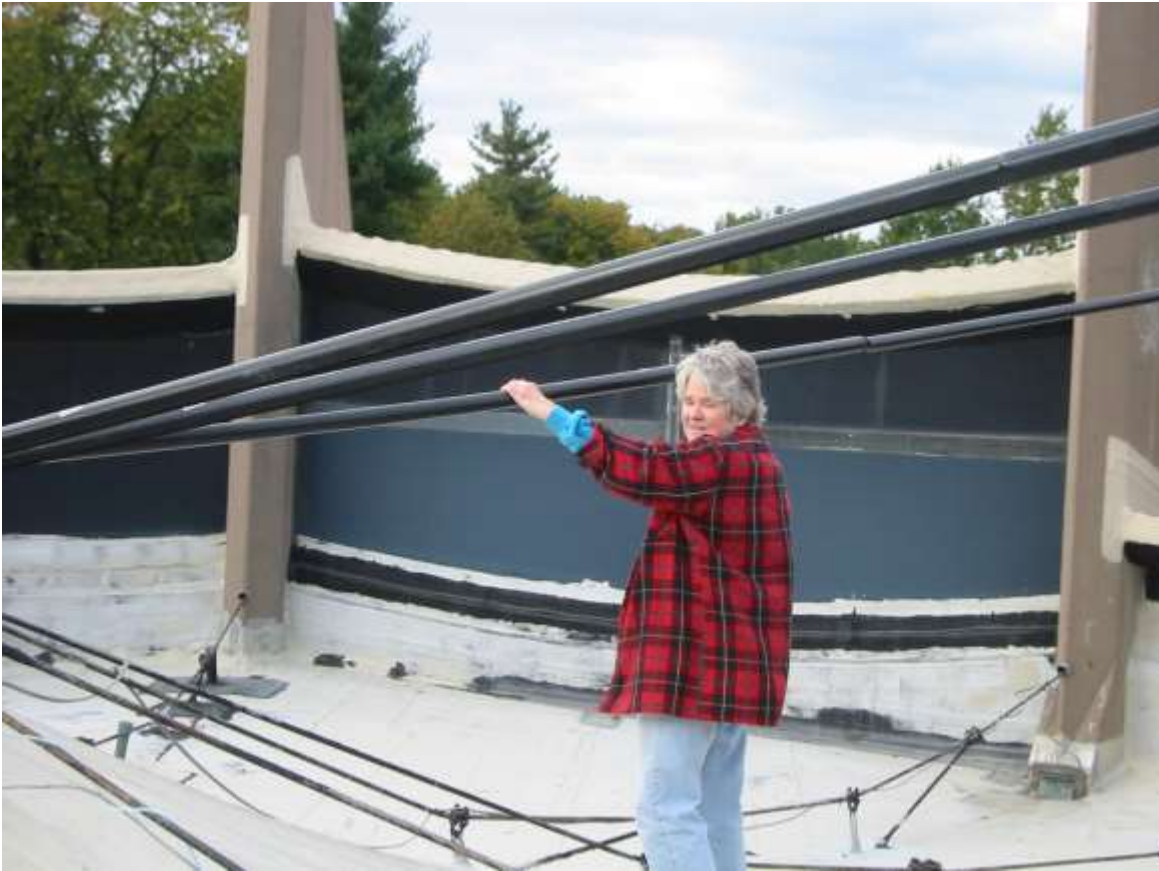
We discovered rain falling on the cables supporting the roof drained down into the support hub, and from there entered the Sanctuary, so we covered the cables in 2005, and that helped.

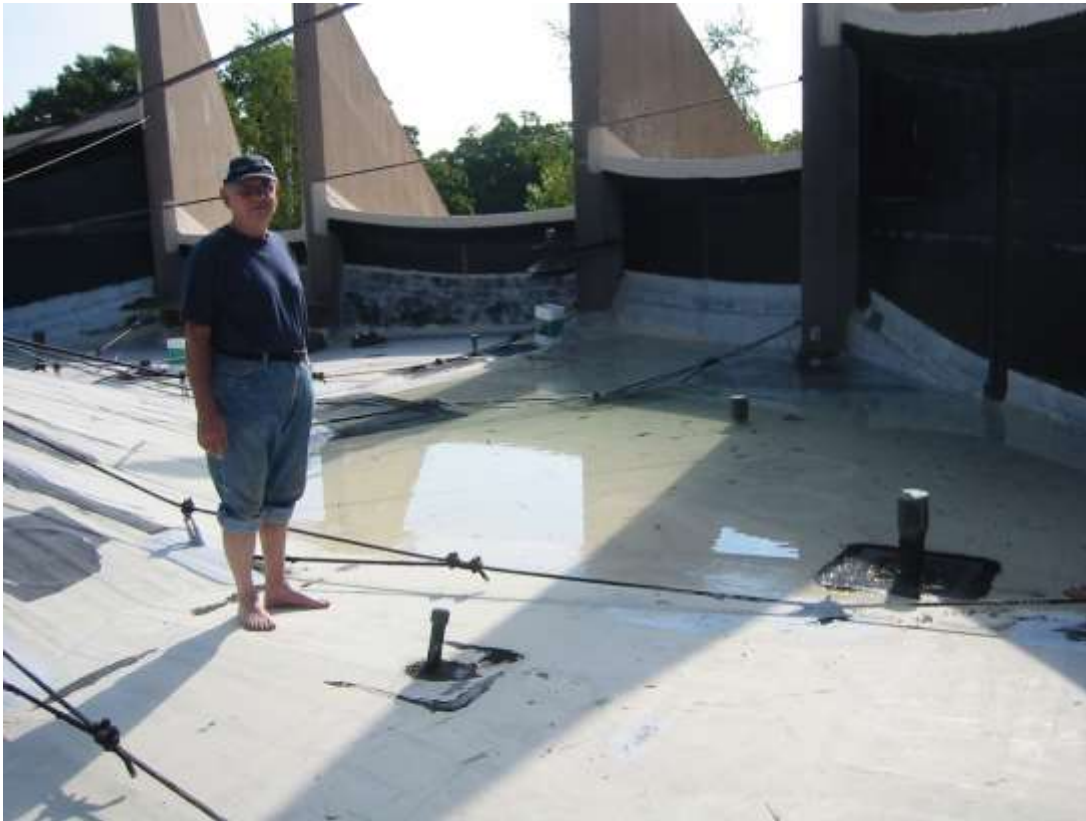
Ponding on the roof continued to be a problem because the drains needed to be improved and debris removal, freezing within, and such matters needed to be prevented. Here Stu prepares to enter the lake and open one of four drains. This particular drain was relined with hose to prevent the leak inside Servetus (October, 2005).

warmed buttress portion inside the building. Further along, the pipe emerging above the roof line into freezing cold weather froze the water in the pipe. As a result, the pipe was fractured deep inside the buttress creating the wall leak in Servetus.

The Servetus wall leak was subsequently addressed by placing a plastic pipe inside the fractured pipe, and, adding roof heating cables to the inside of the drains above the roof line to prevent similar damage. This fix actually worked! Few remaining members know the wet little secret about the Servetus wall. During this time B and G also learned cottonwood fluff would block the drains during May each year causing serious leaking as water ponded on the roof causing pressure. Ultimately the water found holes ending up in the Sanctuary.

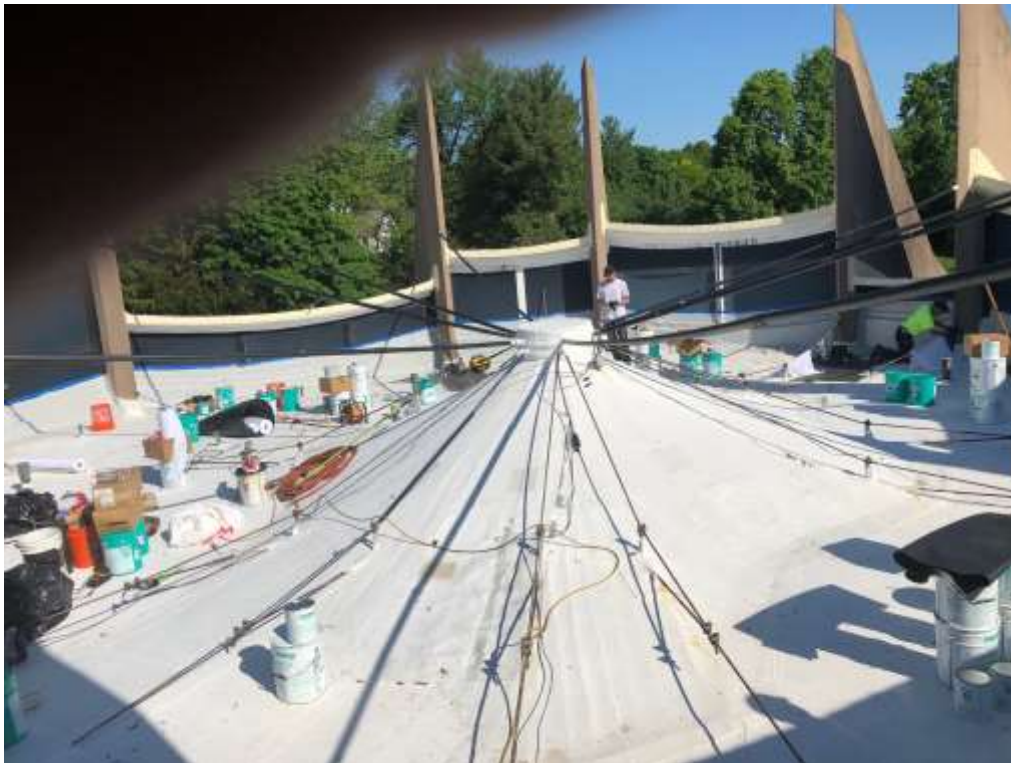
In 2018 a new methodology was employed to repair, recover and improve the roof. Here the contractor is surrounded by buckets of fluids and equipment used to apply a new tough membrane covering the entire roof (May 2018).

However, as more years passed, it became yet more difficult to suppress new leaks in spite of the diligent efforts of Sextons John Bengtson and Kevin Girouard, who spent many a rainy and snowy day on roof repair duty. Consequently, following the requisite preliminary steps guided by our Architect Member, Hugh Schweitzer, a contractor was identified from the Eagle Rivet Roof Service Corporation, who would actually take on the roof repair job. And, to the joy of all participants in the bid solicitation and subsequent planning, there was a new methodology available for doing so. After extensive cleaning and repair of the roof structure and drains, a fluid roofing system was applied. It is termed the Polyurethane Elastomeric Fluid Applied System consisting of a first coat, Tremco AlphaGuard BIO Base coat, and the second coat, Tremco AlphaGuard B10 Top Coat. Together the two coats create a continuous tough membrane over the entire older roof EPDM.

No seams to split apart! The membrane manufacturer, Tremco, Inc., guarantees the resulting membrane for 20 years from the date of substantial completion, about now.

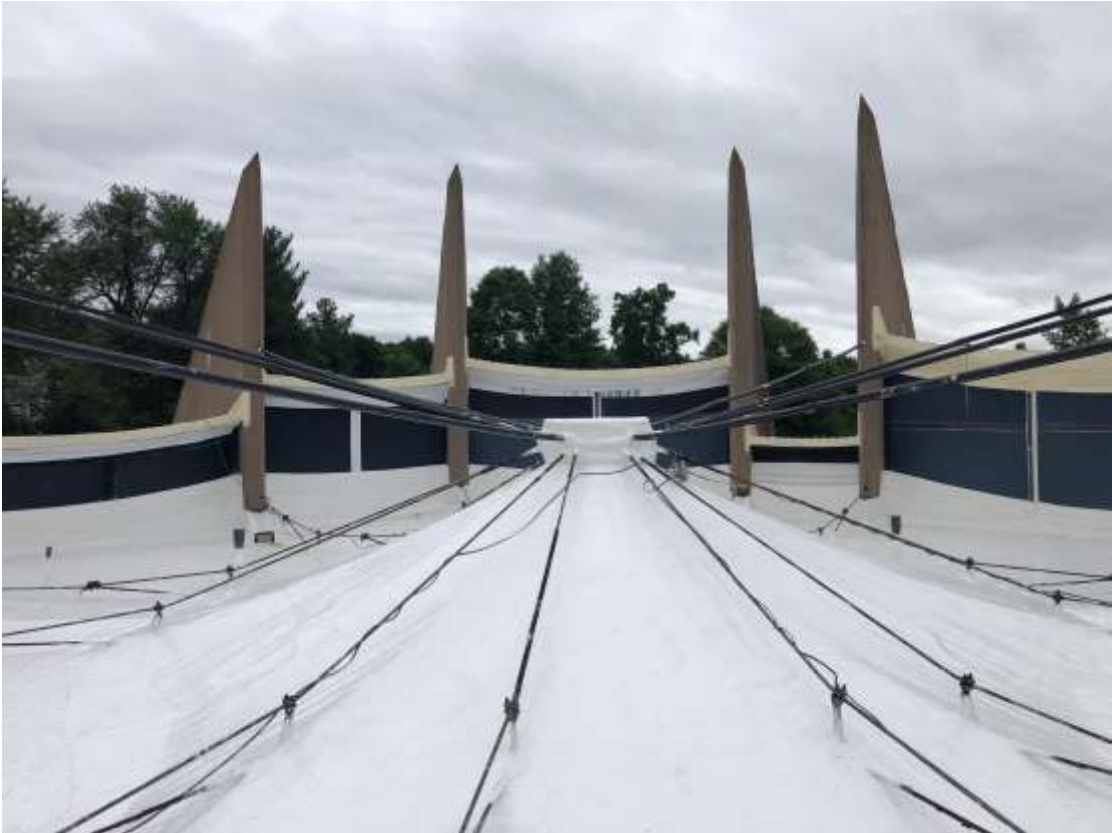
And, now, with the shiny new coating in place, we look forward to an improved situation. It rained with some enthusiasm recently, and there were no leaks! (July 2018)

We have just finished this project supported by an Endowment expenditure of \$40,775. Final inspection has been completed, and substantial rains have occurred with no known leaking. Continuing maintenance of the new drain filters will be necessary and careful operation of the drain heaters during winter will be required.
